Impact and Assessment of Moisture-affected Timber-framed Construction

Technical Design Guides

- #10 Timber Windows and Doors
- #11 Timber-framed Systems for External Noise
- #12 Impact and Assessment of Moisture-affected, Timber-framed Construction

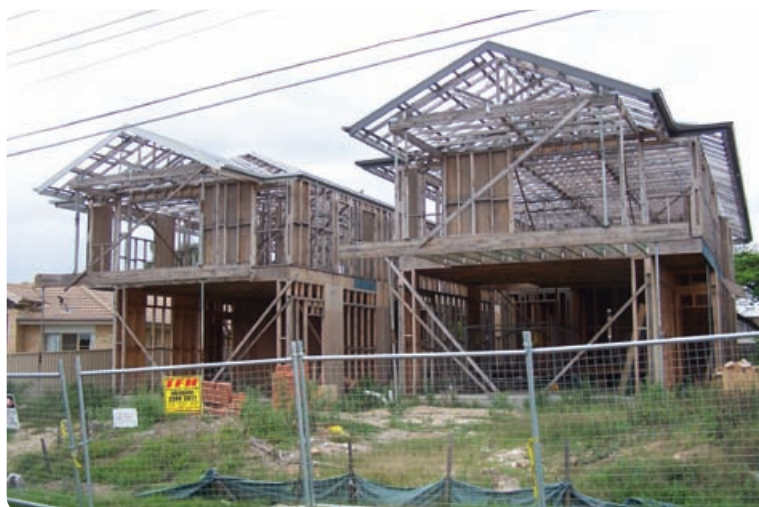
Timber frames exposed to the weather for six months.

Moisture content 20% or above is conducive to decay and needs to be addressed.

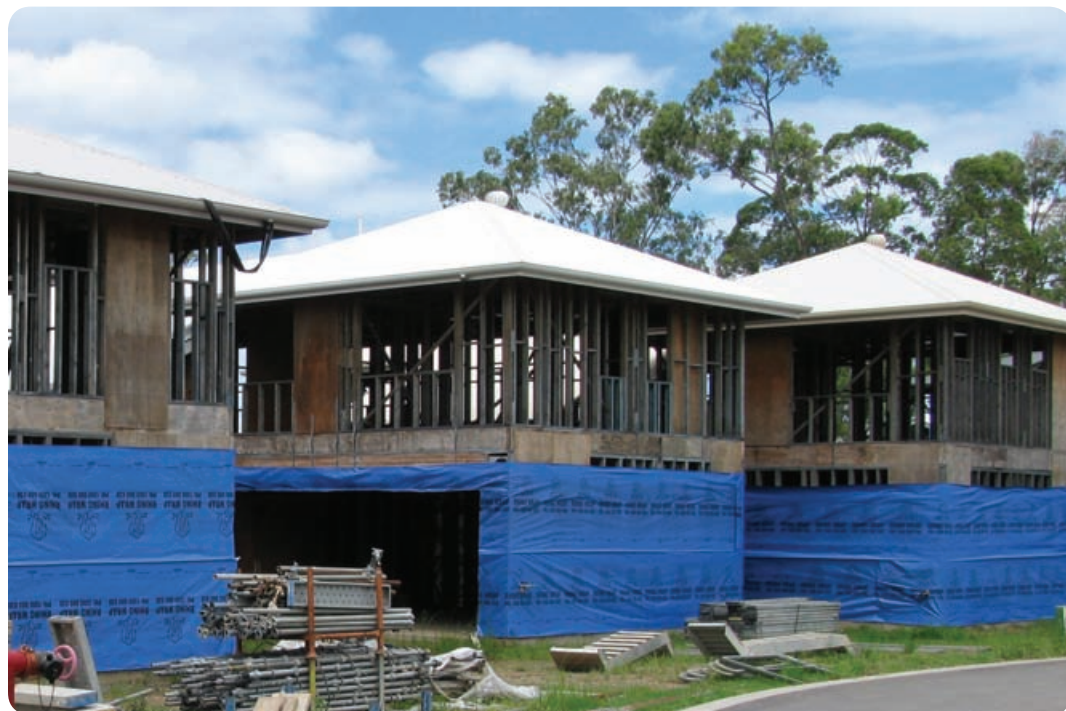
Exposed timber can become discolored and stained.

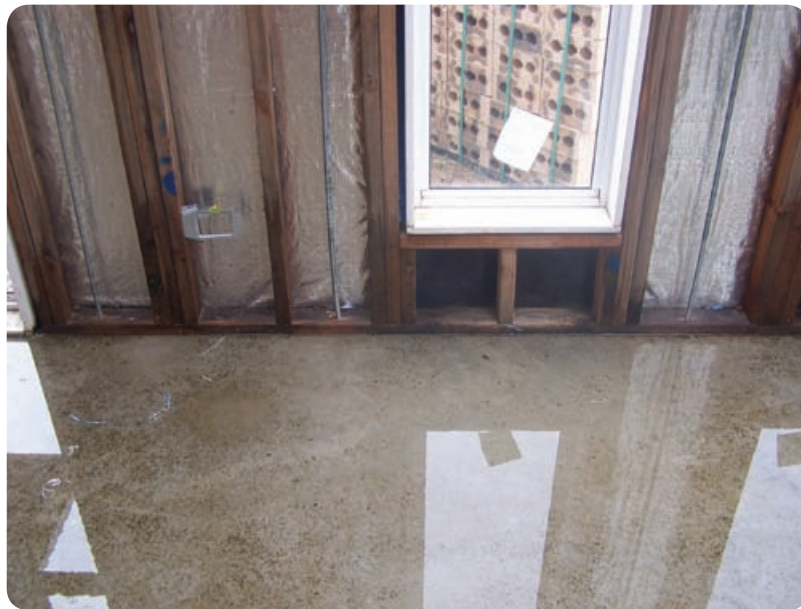
Water ponding on slab. Note wicking of moisture up the studs.

The areas of a weather-exposed frame likely to have the highest moisture content are bottom plates on slabs or sheet floors and the lower ends of studs on these plates due to wicking action.

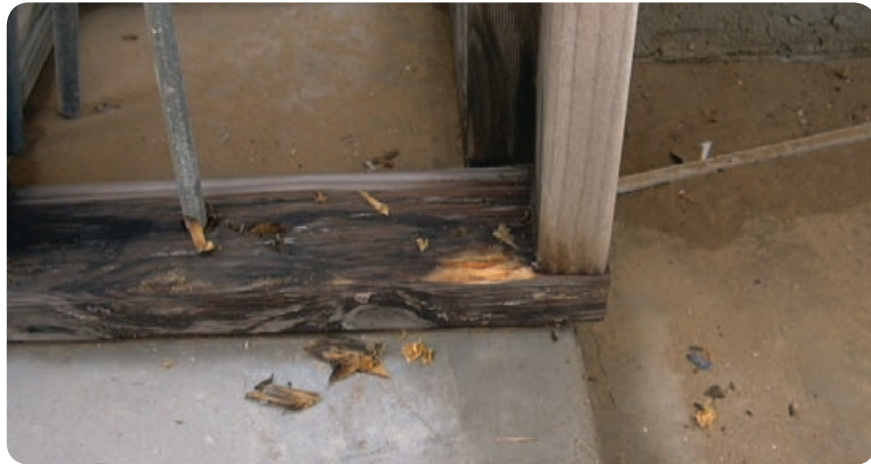
Significant discolouration due to stain but timber under surface is unaffected, with no decay.

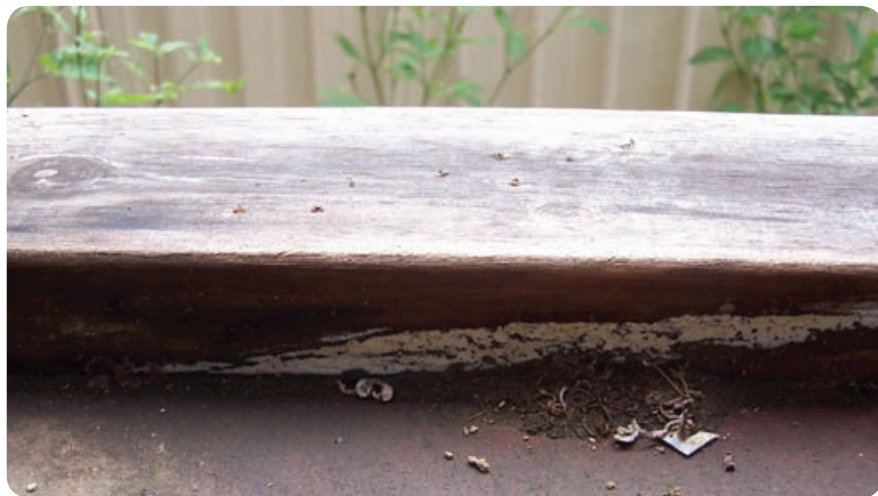
Decay in bottom plate on particleboard floor. Note small drill holes on top of plate used to detect decay.

Drilling using a fine auger or drill bit enables assessment deeper into the timber. Again, for the equipment being used, the force required to penetrate sound timber should be compared to the force required to penetrate affected timber. Timber that has decayed will be far more easily penetrated.

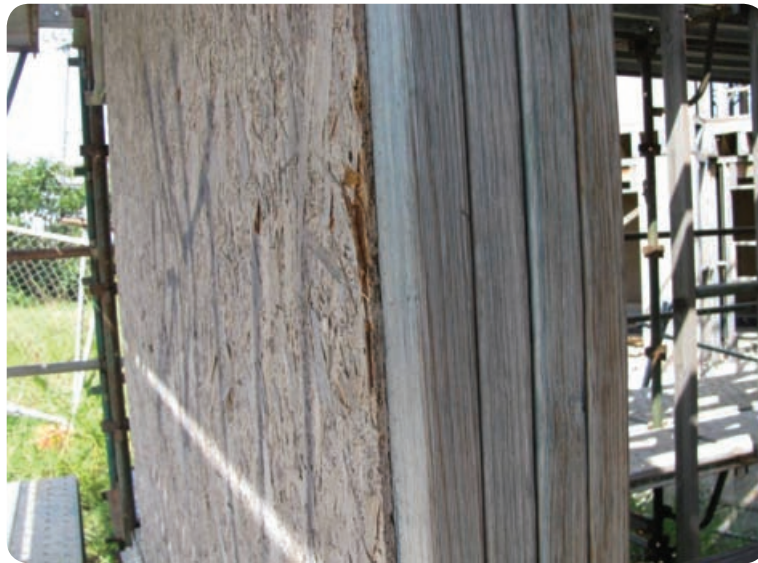
Example of OSB sheet bracing showing edge swelling and flaking.

With all sheet bracing types, the critical areas for evaluation are the sheet edges where the nail or other fasteners attach the sheet to the frame. Any degradation of the sheet edges will compromise the structural adequacy and shear capacity of the fasteners which, in turn, will affect the design capacity of the bracing.

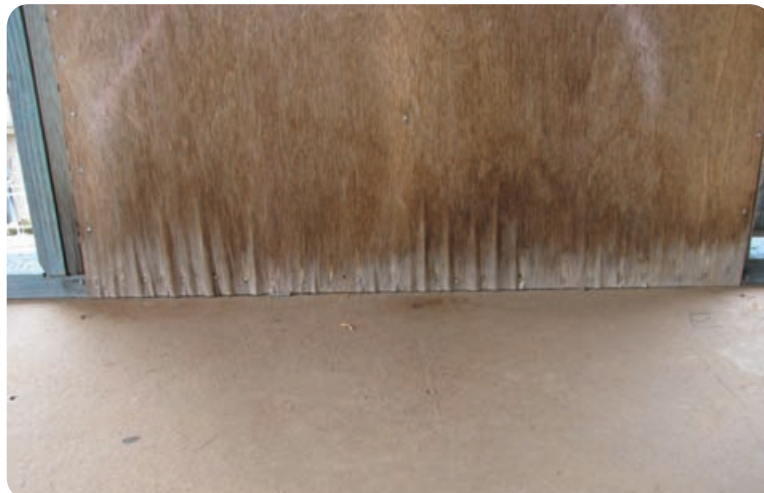
Plywood delamination at bottom plate in bracing panel. Note: The plywood used in the construction in the above example had no identification stamps or indication of certification schemes or Australian Standard for its manufacture.

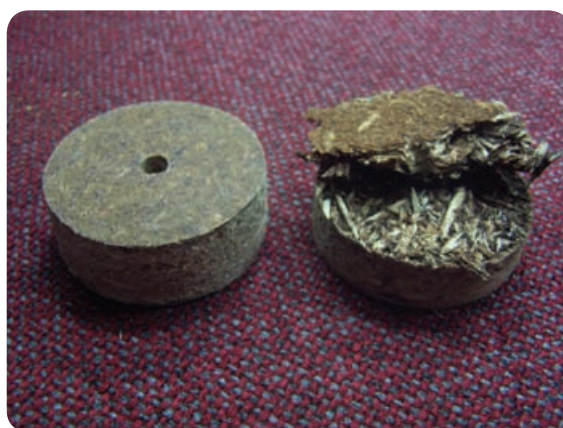
Typical hole saw samples.

An additional advantage of taking hole saw samples is that the moisture content in the board can be ascertained by oven dry testing. This also enables the thickness of the sample to be measured following drying to determine the extent of any non-recoverable swelling.

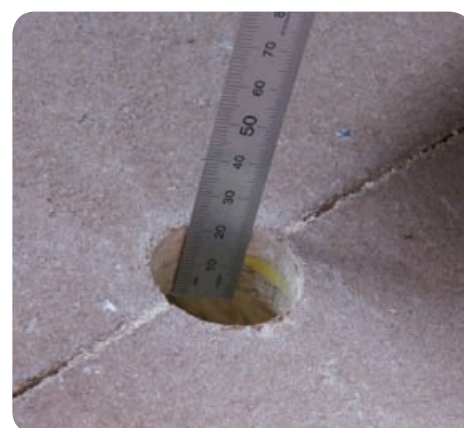
Measuring the thickness of particleboard flooring at a hole saw sample location.

Taking a hole saw sample of particleboard flooring means you can compare the sample to the manufacturers stated thickness.

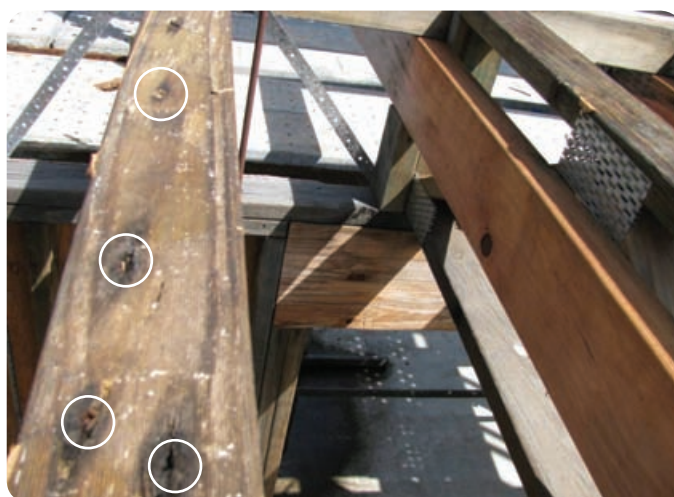
Decay pockets (highlighted) around fixing points where sheet flooring has been removed after 12 months' weather exposure.

Moisture can track down fittings into joists, creating local decay pockets.

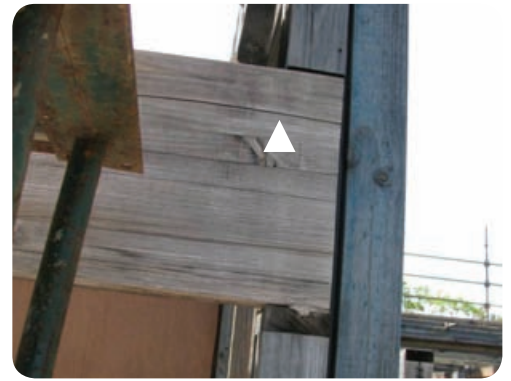
Split (indicated by arrow) along second top laminate (does not follow glue line) at end of beam.

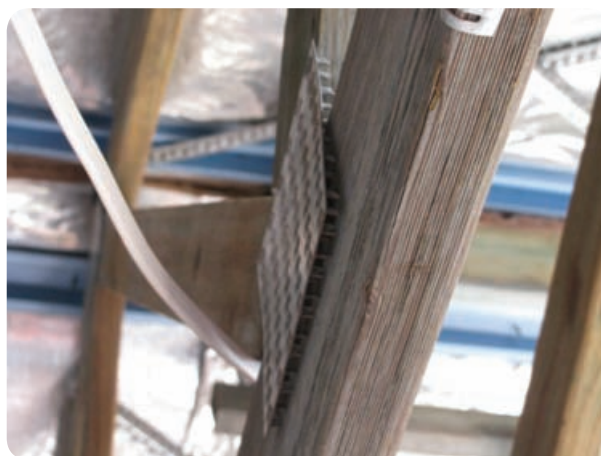
Loose truss plates where trusses exposed to weather for six months (prior to roofing being installed).

Repeated cycles of wetting and drying of nailed plated timber often leads to the nailplates loosening.

Repeated cycles of wetting and drying of nail-plated (truss plates) timber products frequently leads to the nailplates 'withdrawing' from the timber due to the associated cyclic expansion and contraction in the timber. In extreme cases, the plates may totally disengage. Where the gap between the plates and the timber is more than 1-2 mm, which can be measured using feeler gauges, the structural integrity of the members or product may be severely compromised. If the structural integrity is in doubt, the nail plate/product manufacturer's advice on repair or replacement should be sought.

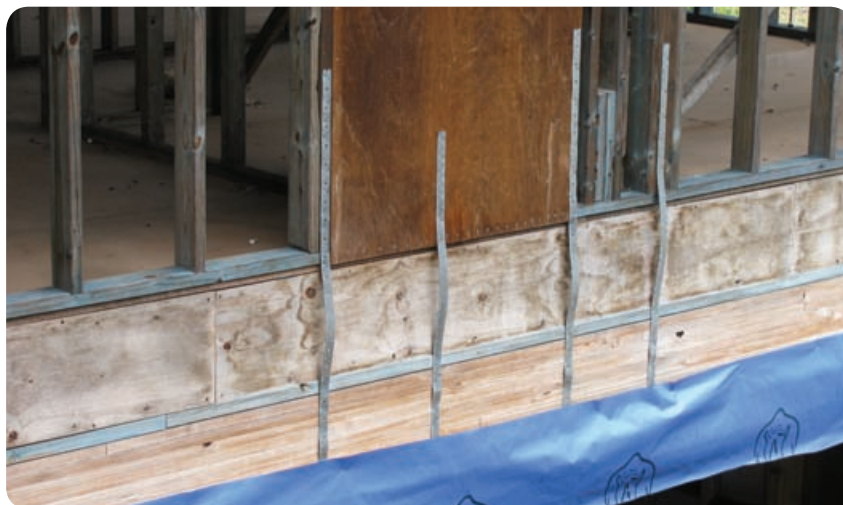
Loose tie-down steps due to timber expansion and then subsequent shrinkage.

As shown in the example below, the weather exposure of frames can cause connections such as straps and tie-down rods to become loose. This can be due to either minor frame settlement and/or wetting and expansion of the timbers and subsequent drying and shrinkage. These situations will not usually be due to degradation of the timber in the frames and can be easily rectified. They should not present any real structural concerns.

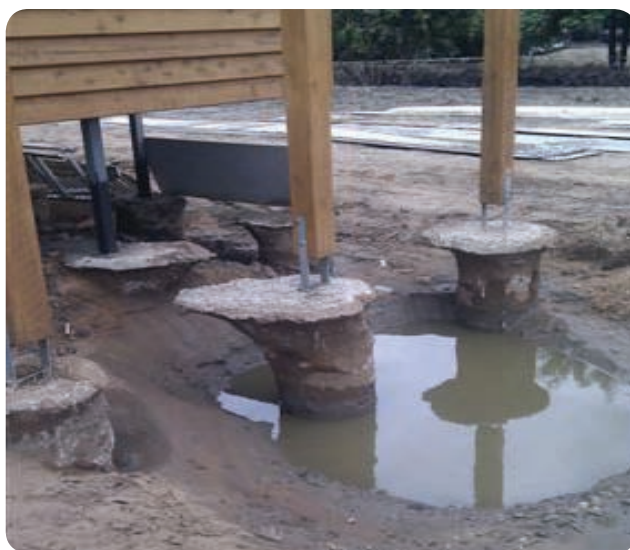
Footings scoured out by floodwaters (Image: BSA Queensland).

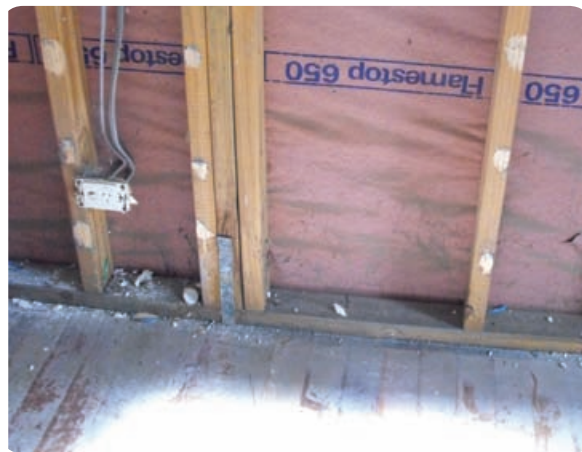
Although quite stained and covered with mud and silt, when cleaned, the pine framing found to be unaffected

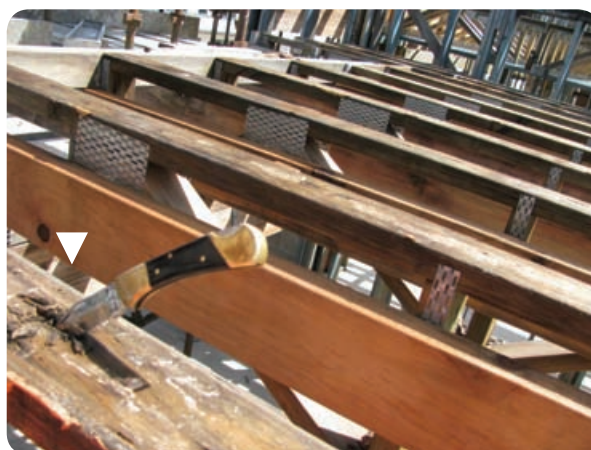
Locate decay by probing.

Decayed timber is soft and spongy and can easily be penetrated with a knife or screwdriver (see arrow).

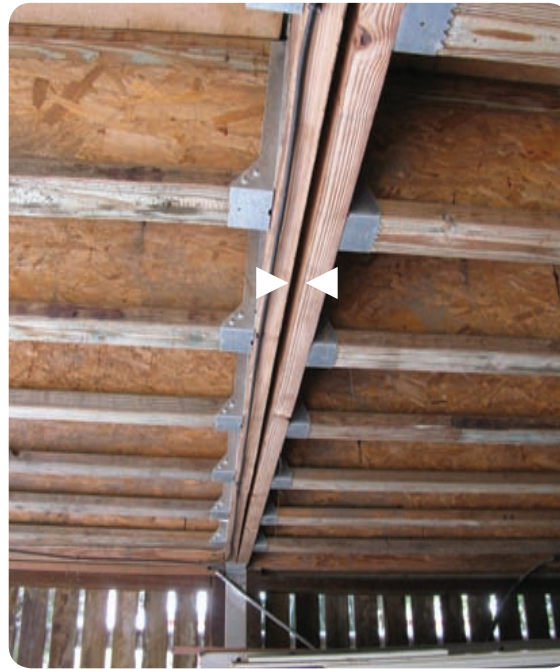
Expansion in flood-affected timber flooring.

Expansion of the hardwood T&G floor above has caused the separation of double bearers (see arrows).

Timber and wood-based products that have been saturated will swell. When they dry out, they will shrink. The amount of swelling or shrinkage depends on the type and species of timber or type of wood product, and the time exposed to water. Where timber has swollen in, for example, flooring, it may also have secondary effects such as cupping and pushing out external walls or movement of joists and bearers.

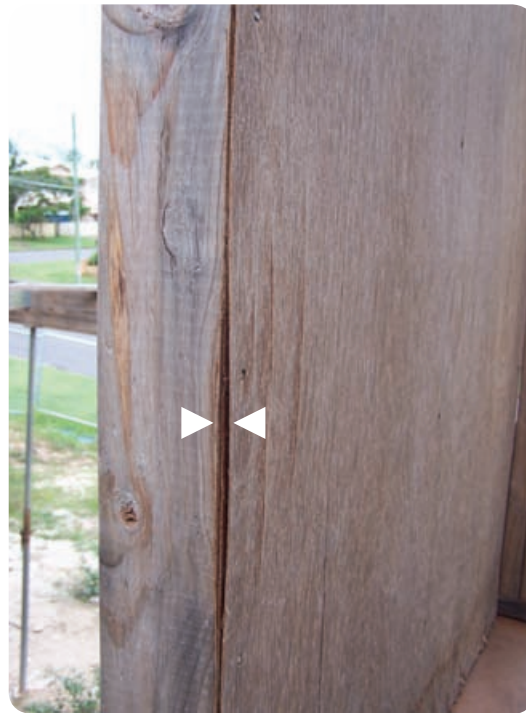
Delamination of plywood sheet bracing (see arrows).

Plywood sheet bracing affected by moisture. Replacement required. Where necessary fix temporary braces.

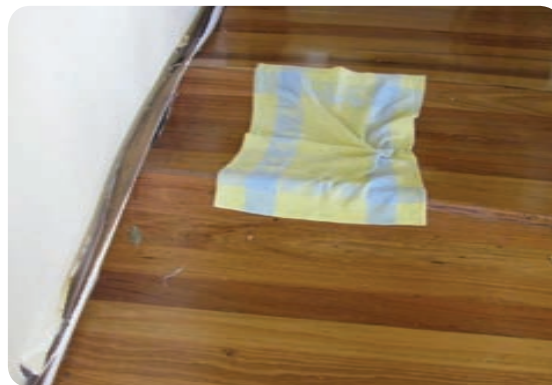
Tenting of T&G floor due to prolonged moisture being trapped under the floor. This inundated T&G floor supported on a particleboard sub-floor 'tented' about one week after the flood water receded.

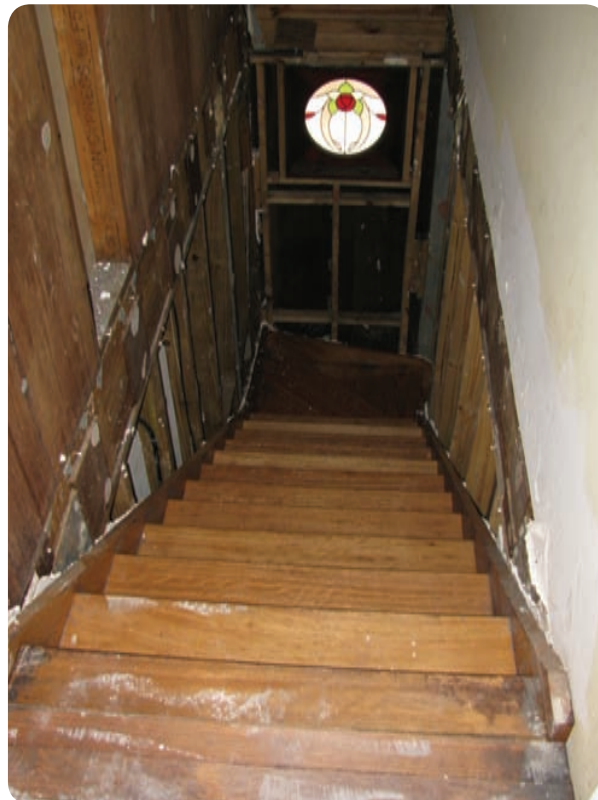
Solid timber stairs stripped out and allowed to dry were recovered following inundation.

Stairs constructed from solid timber (hardwood or softwood), glued-laminated timber or structural plywood can usually be recovered provided any surface materials, such as carpet, attached to the underlying stair structure are removed, and the stairs are allowed to dry quickly. Because of their nature, with many housed joints, etc, forced mechanical ventilation or dehumidification may be required to enable timely drying of the stair system.

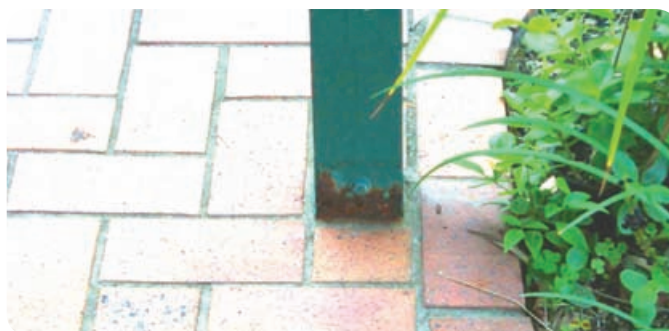
Significant corrosion of embedded galvanised steel post bracket.

When assessing timber construction, pay attention to the potential impacts of corroded metal components and connections. Pay particular attention to any non-galvanised items, including bright steel nails, bolts or screws and also to galvanised components such as SHS posts or stirrups that are embedded in concrete and will be susceptible to corrosion at the top of footing. It may be necessary to remove some items (screws/bolts, etc) to assess the extent of corrosion on the embedded portion of the fastener. Where rust is present but the posts are still viable, they should be cleaned, treated with phosphoric acid, and then sealed with a metal primer, followed by subsequent coats of a metal or bituminous paint product.

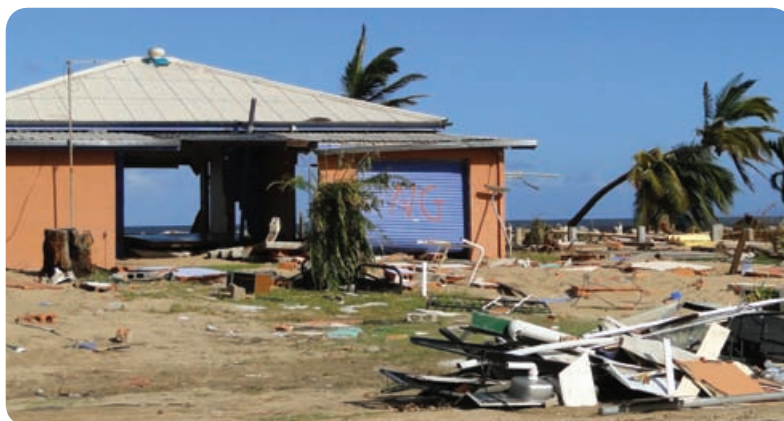
Storm surge damage to a slab on ground house.
(Image: Cyclone Testing Station, James Cook University, Townsville)

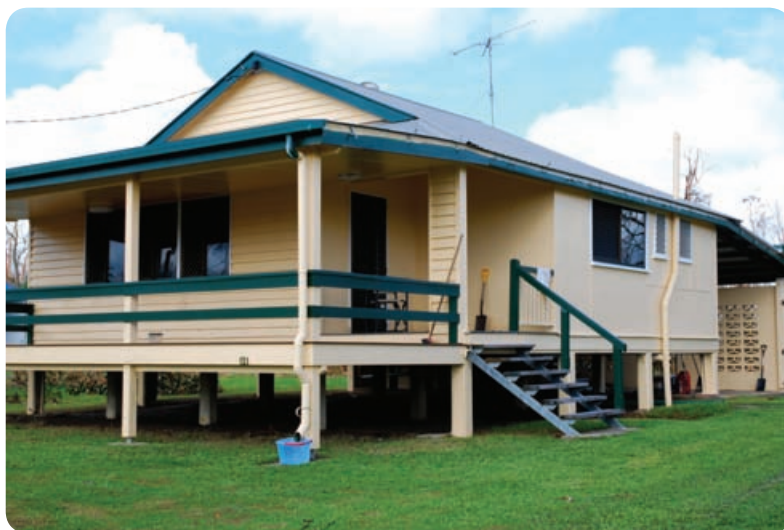
Elevated houses suffered little storm surge damage.
(Image: Cyclone Testing Station, James Cook University, Townsville)

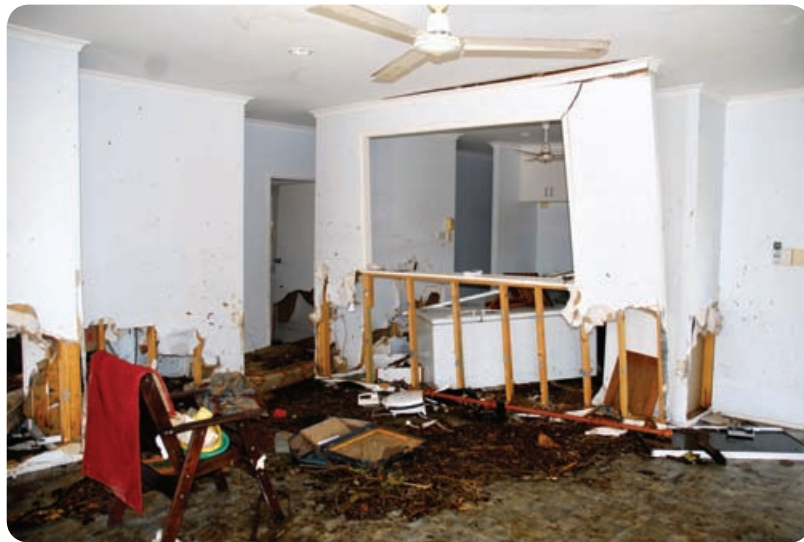
Storm surge structural damage. (Image: Cyclone Testing Station, James Cook University, Townsville)

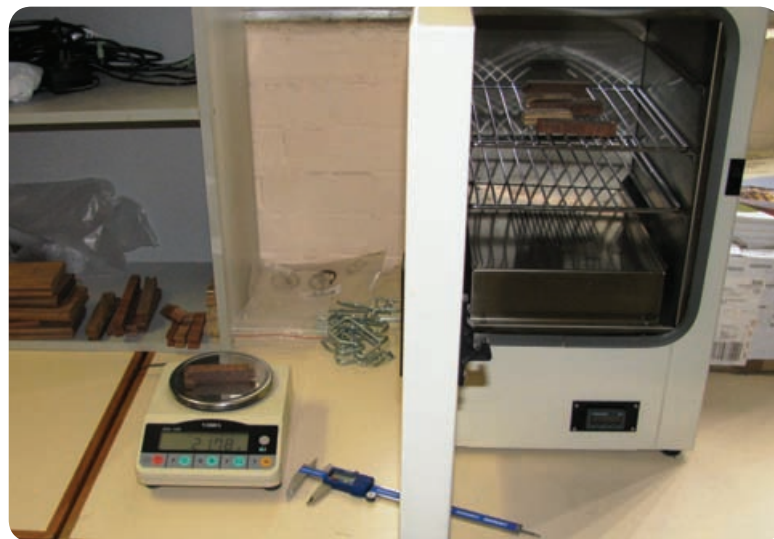
- The equipment required is an accurate electronic digital scales (± 0.2 grams) and a laboratory oven that is able to maintain a temperature of $103^{\circ}\text{C} \pm 2^{\circ}\text{C}$.

Oven dry moisture content measurement.

- Oven dry testing is often carried out where there are variations in the MC of the final product.
- It can have a significant affect on the performance of the product. In case of disputes, Australian Standards generally refer to this method as it provides measurements that are more accurate and reliable. For some products, such as preservative-treated timber or particleboard, it is the only method recommended.
- Manufacturers of board products often undertake oven dry testing as a check in the manufacture of their products.
- A number of organisations have the appropriate testing equipment and contract out these services.

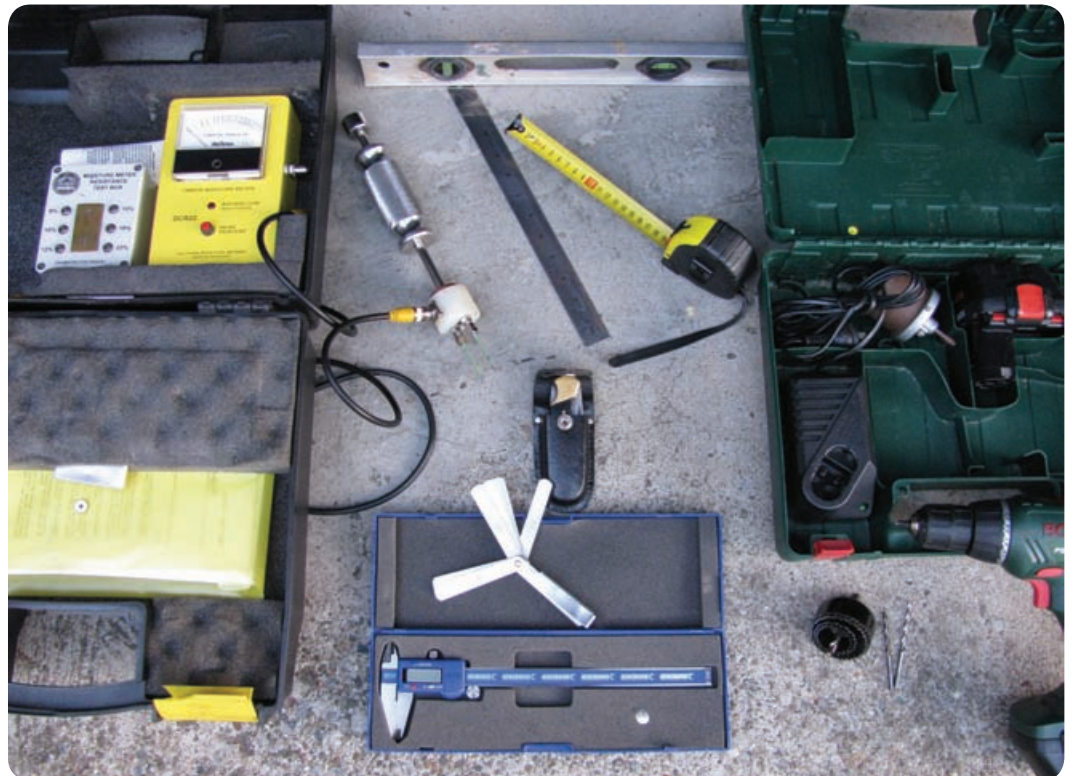
Typical range of site assessment tools.

String line: Useful for assessing out of straightness over long distances.

Compass: It is usually important when undertaking site inspections and reports to be able to determine north. This assists with recording site locations of measurements and also can aid in understanding assessment issues that may arise on-site between one part of the building and another.

Site notebook: Record findings on-site such as locations, measurements, sketches, moisture readings, etc. Don't trust your memory.
